INTERNATIONAL CONFERENCE INTERVENTION APPROACHES
FOR THE 20TH CENTURY ARCHITECTURAL HERITAGE
CRITERIOS DE INTERVENCIÓN EN EL PATRIMONIO ARQUITECTÓNICO DEL S20
madrid · june 14-15-16 · 2011

E.1027. MAISON EN BORD DE MER: Theoretical Restoration

***E.1027. MAISON EN BORD DE MER*: Restauración conceptual**

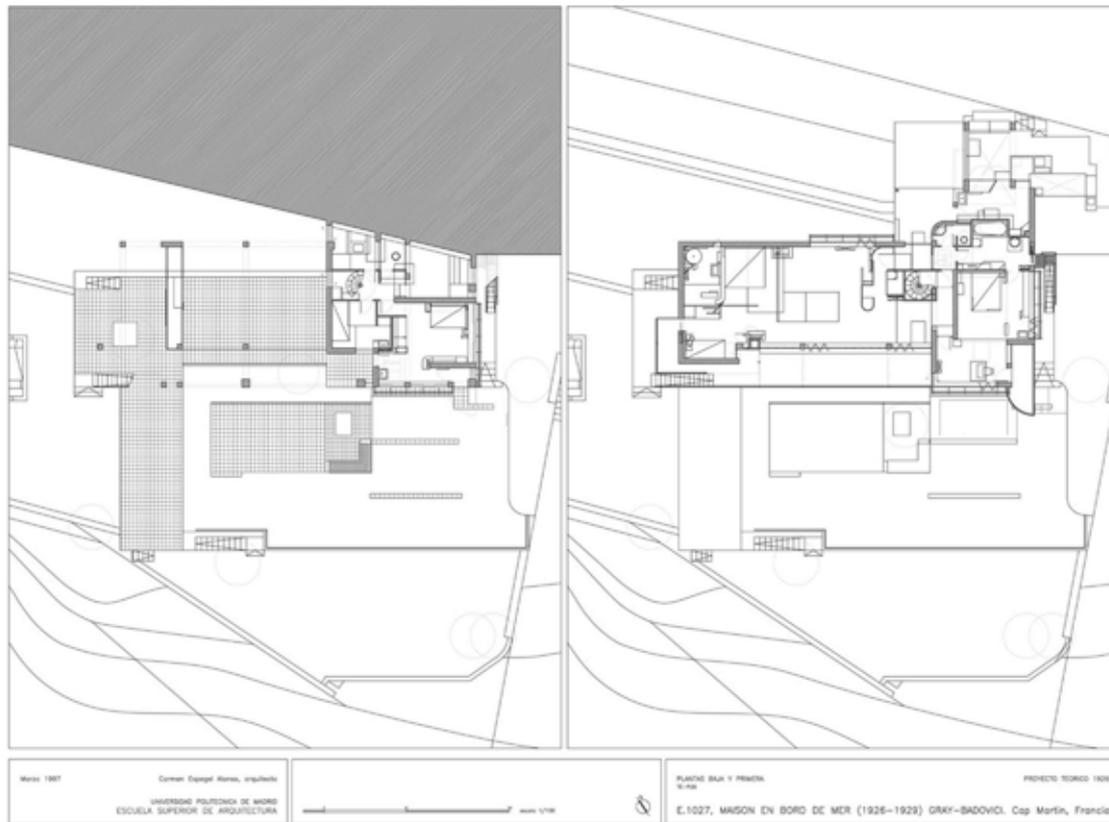
Fig 1. Ground and first floor. Theoretical project, 1926

The initial project of *E.1027* house was drawn in 1926 upon a precise geometry and implied a clear relationship between the whole volume and its individual parts (Figs. 1-3). The complexity of the structure can already be appreciated in sketches of a previous version of the house.³ The preliminary project is represented with great simplicity, in very abstract renderings. The interior design of each room was exhaustively developed. There was a vertical chimney-like element located where the glass hood and spiral staircase were later built.

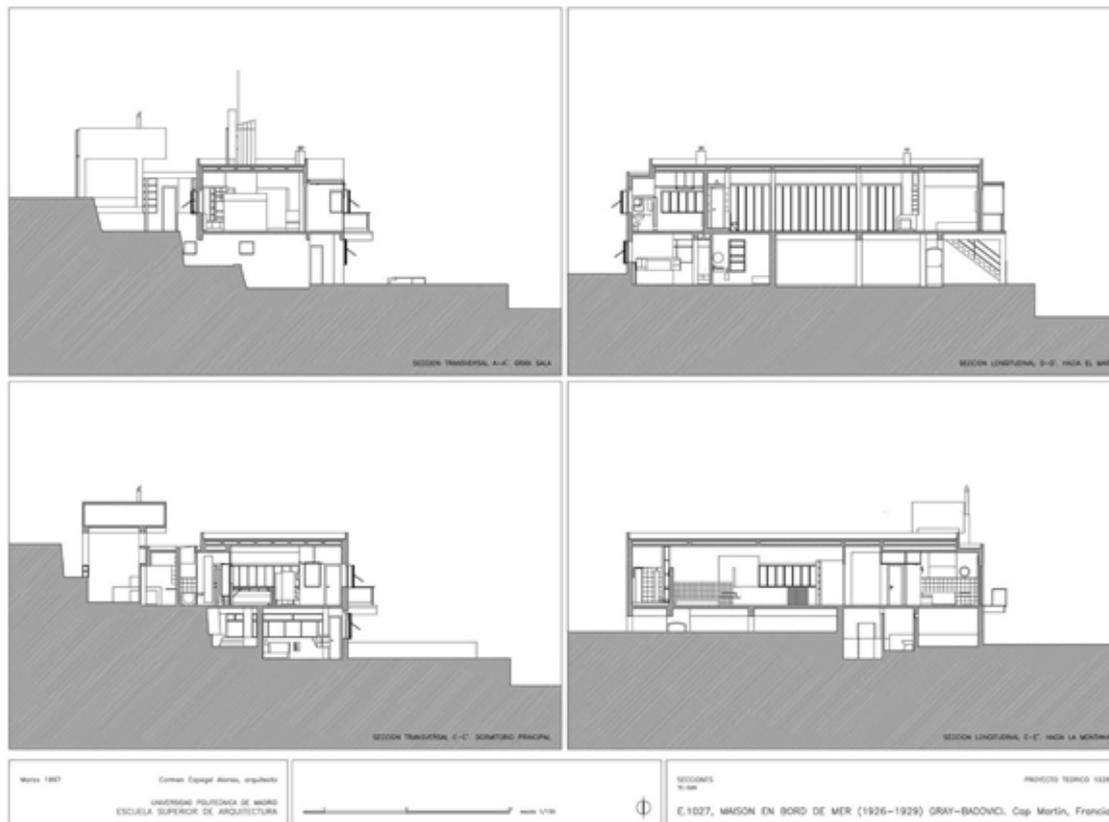
Fig 2. Cross and longitudinal sections. Theoretical project, 1926

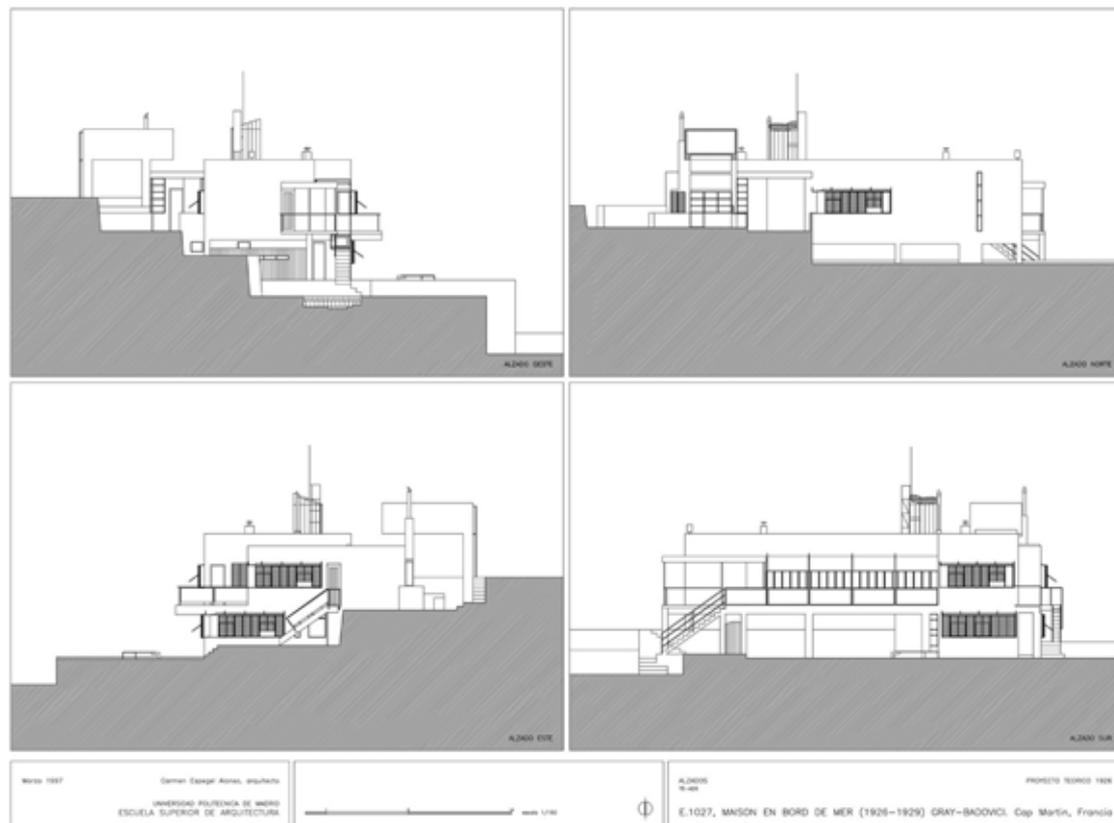
Fig 3. Elevations. Theoretical project, 1926

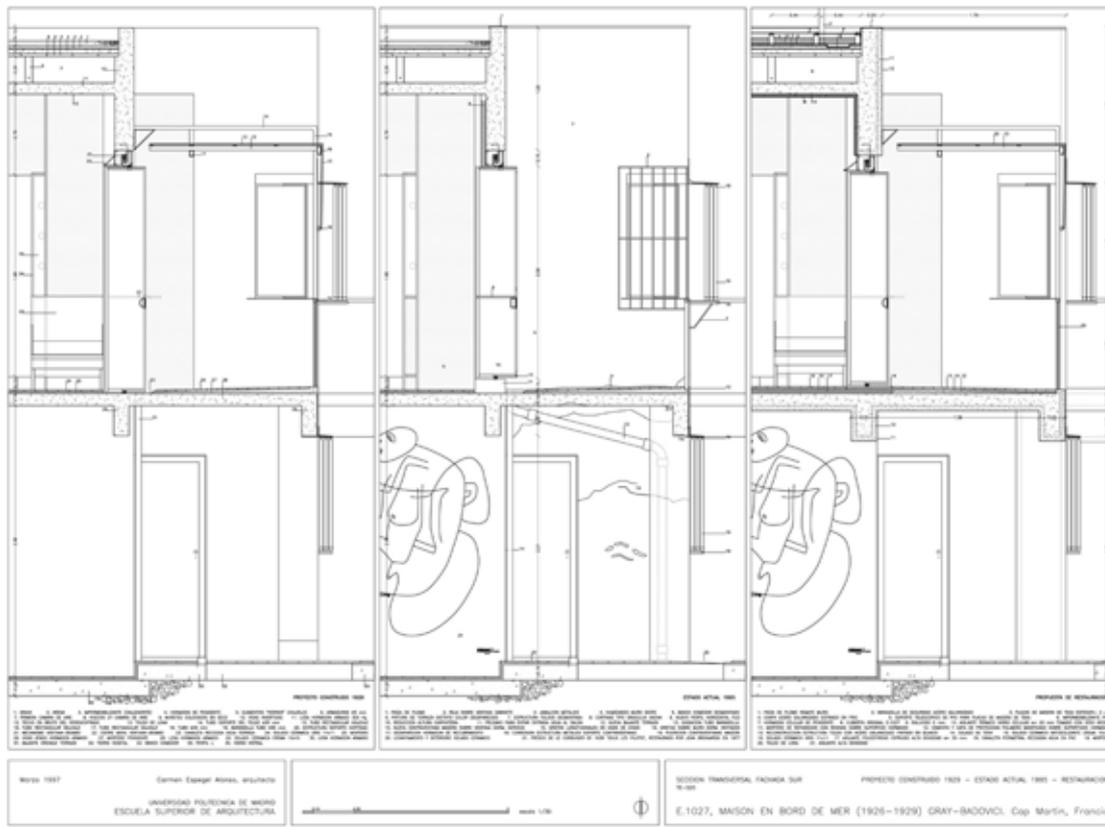
Fig 4. Cross section, Southern façade. Built project, 1929 / Current state, 1995 / Theoretical restoration

The main aspects of this restoration aim to recover the total original spatial conception, remove later additions and reconstruct missing elements, and preserve the typologies of materials and construction techniques. The project itself would recover the original 1929 state of the house and remove later additions, particularly those which transformed the multiple and complex circulation scheme of the house and those that invalidated spatial continuity between the interior, the covered exterior (terrace) and the outdoor grounds (Fig. 4).
